OK, let's go ahead and get started on this roof, but first, we must remove the rust.

This '40 Willys roof panel has more than 90% of the rust removed. One more application will get it. I have a little under three hours in it to this point.

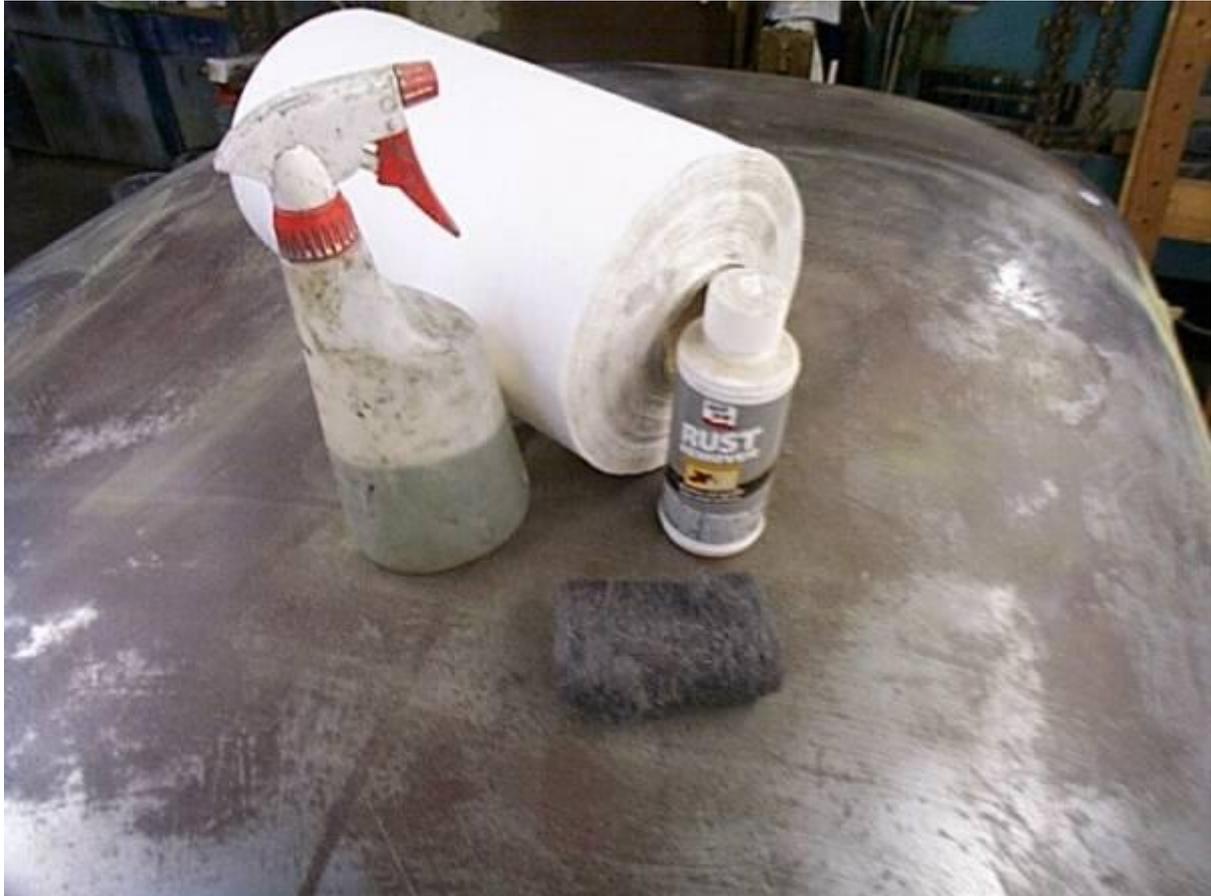
Let's start with a materials list. You will need a DA sander (any type will actually work, or you can sand by hand if you wish) 80-180 grit sandpaper, steel wool (any grade will work), Naval Jelly, a squirt bottle w/warm soapy water and a roll of paper towels.

The first step is to sand the entire surface rusted area with a DA sander fitted with 80-180 grit paper. We're not trying to sand off the rust entirely, just get the majority of the heavy rust and make the panel somewhat smooth.

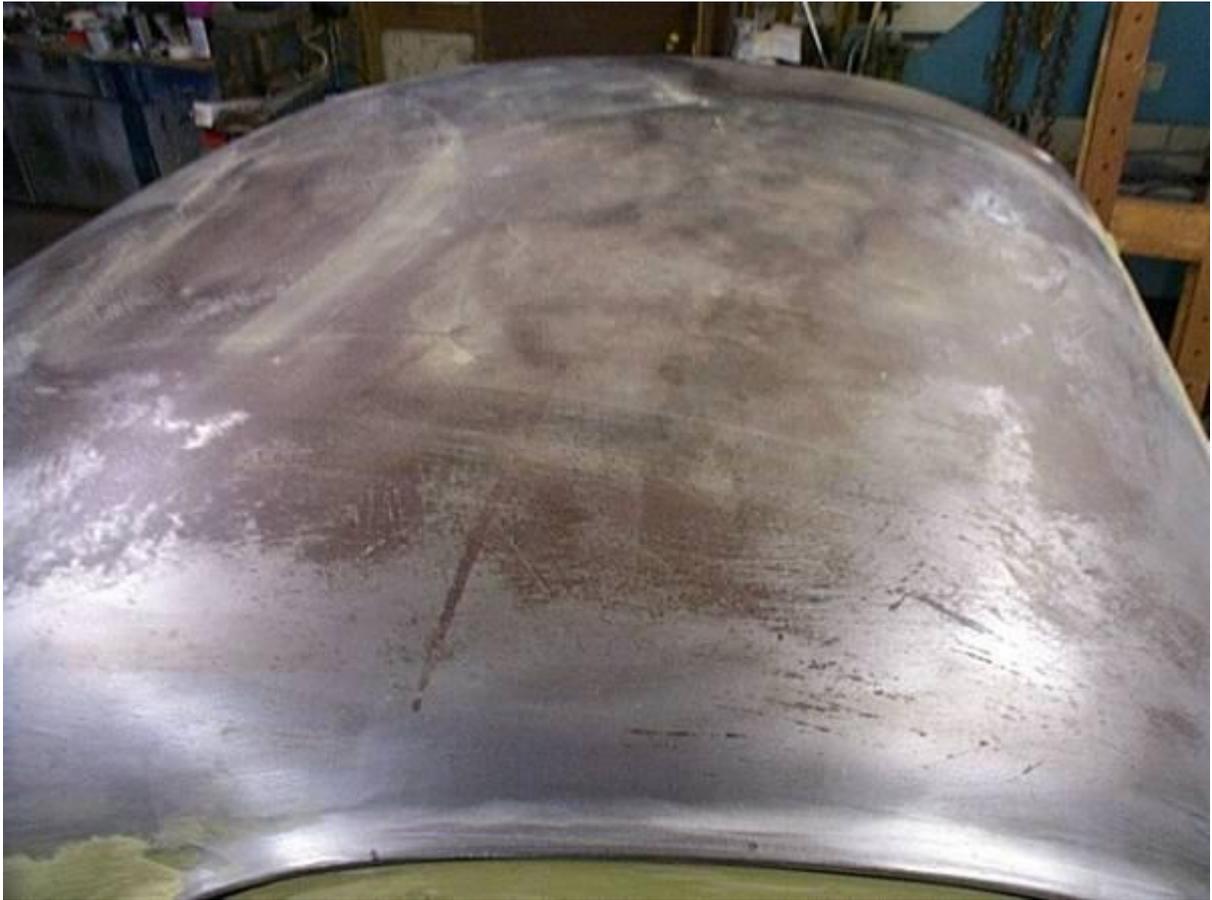
Working in an area about 12"-16" square, apply a fair amount of naval jelly and start scrubbing with the steel wool. It's wise to wear rubber gloves, as the phosphoric acid in the naval jelly may affect your skin!!

It is important to keep the area wet at all times. Do not allow the naval jelly to dry. A few shots of water from the squirt bottle will help to activate the acid and may aid in quicker results. Depending on the severity of the rust, you should start seeing shiny metal within a few minutes. You may have to rinse the area and re-apply the naval jelly several times to get it all, but it WILL remove the rust eventually. When you're finished working an area or you need a break, wipe off the excess naval jelly with a paper towel, squirt a healthy dose of the warm soapy water on the work area and immediately dry it thoroughly. This will neutralize the acid and leave a bluish coloured film on the metal.

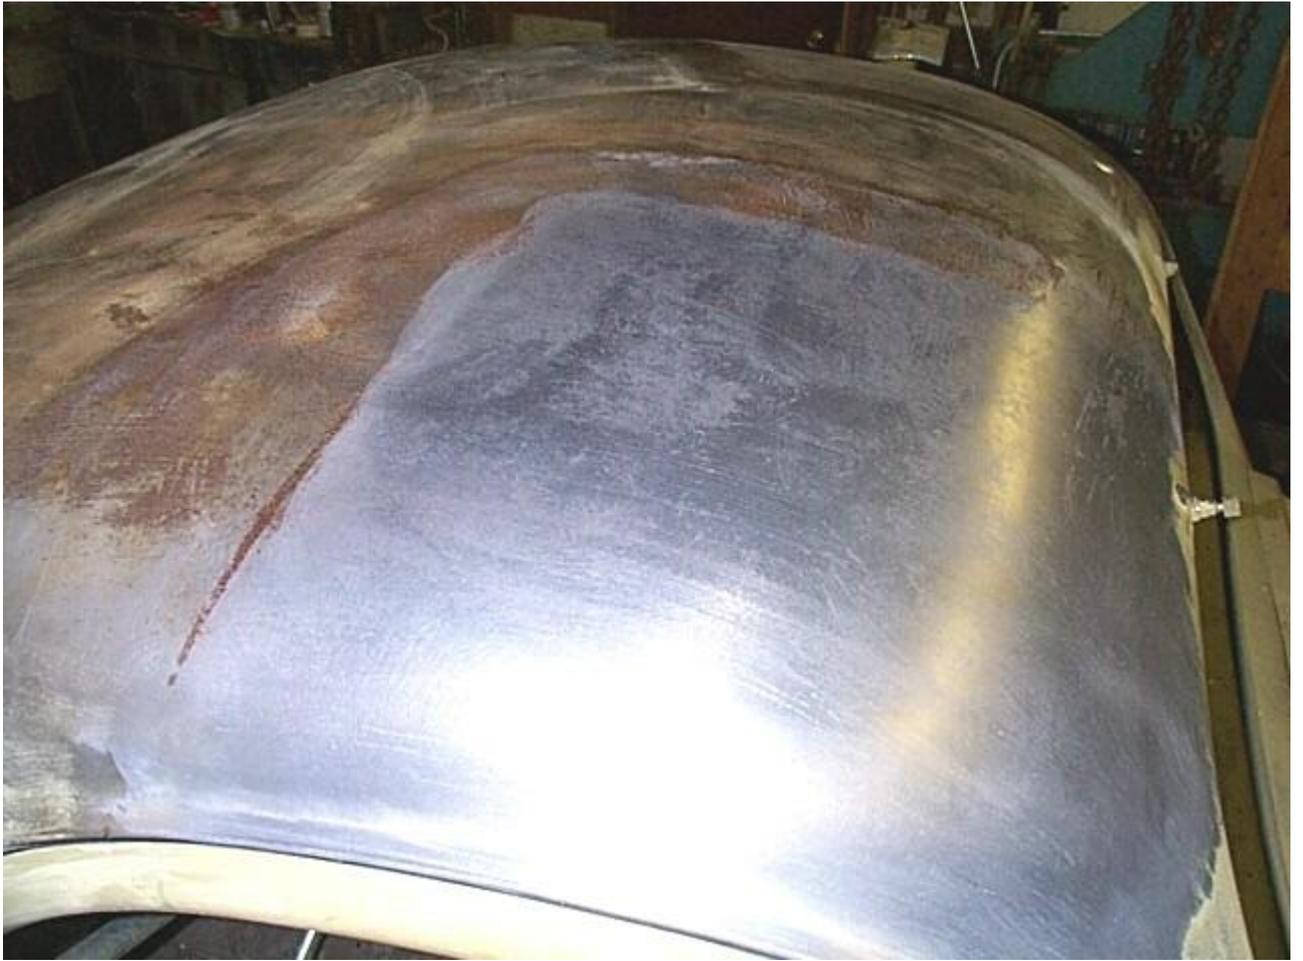
I did this 16"x16" area in about 15 minutes. More extreme rust would have taken longer, but the end result would have been the same.

Repeating this process over and over in workable size areas will yield a rust free panel that is ready for a good coat of epoxy primer that will last years, with just a few hours of good old hard work!!!

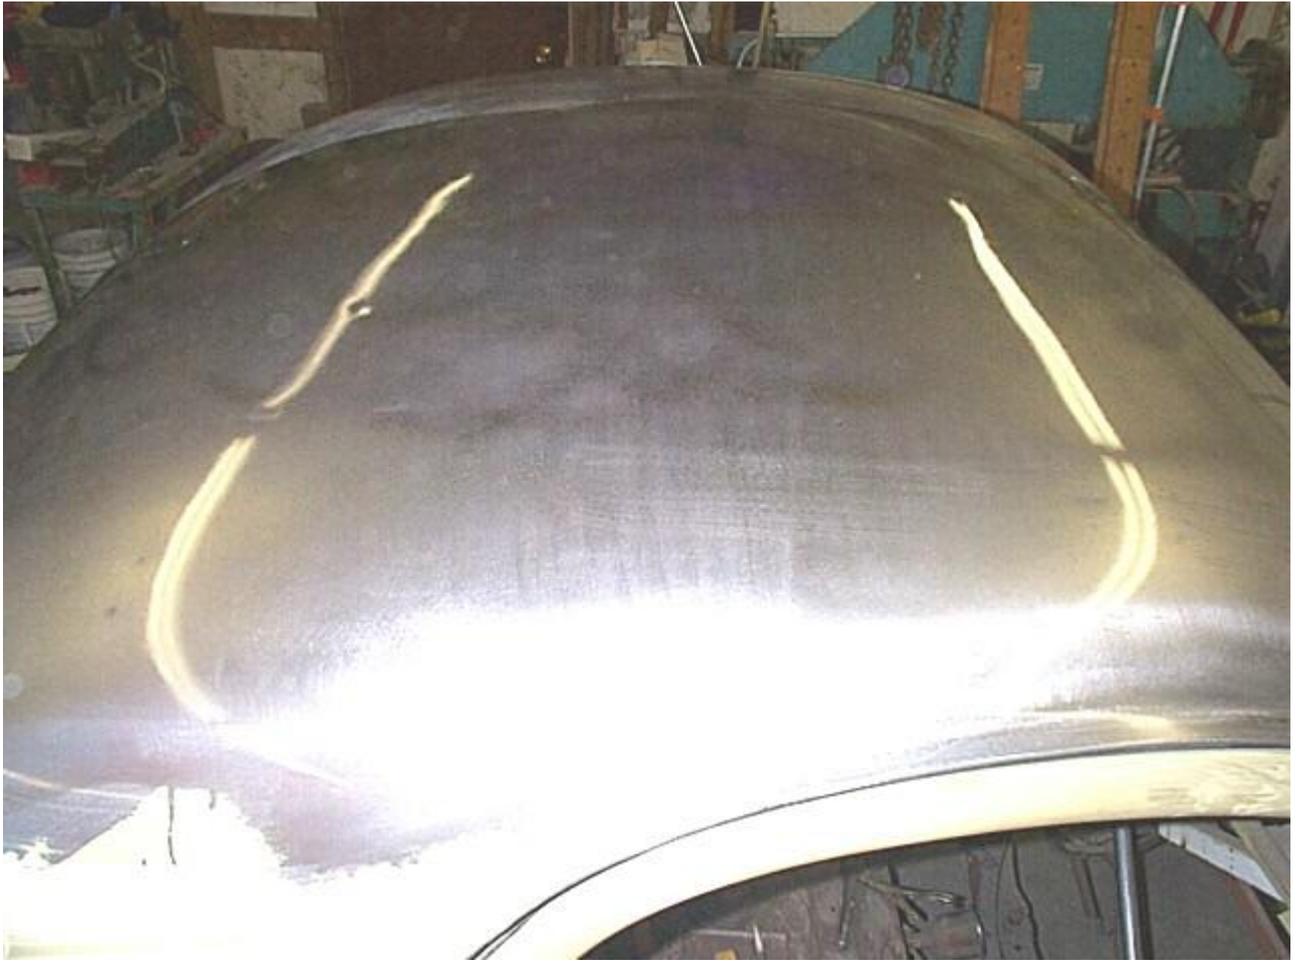
The last picture was taken just after wiping the panel with a wax and grease remover. I did this to clean it up and also to help highlight the dents. If you look closely, you will notice several half moon shaped creases in the roof. This all gets repaired in the next step.
